**THE DON DISTRICT SALMON FISHERY BOARD
HABITAT IMPROVEMENT WORKS
LEOCHEL BURN**

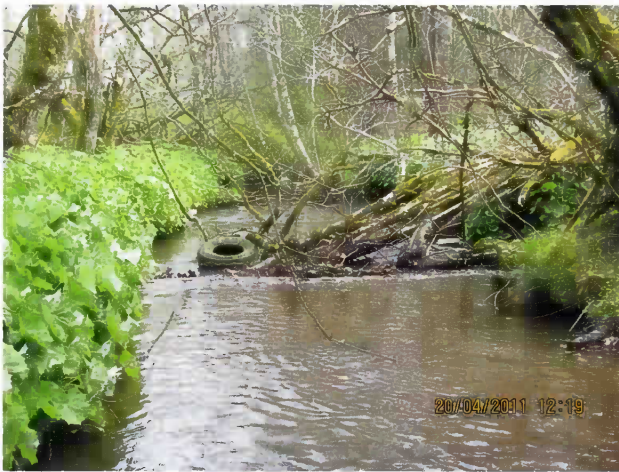
Other obstructions were caused by over grown willow trees that had collapsed at some stage, rerooted and were growing into the stream as you can see in the picture on the right.

This type of obstruction causes considerable damage to bank habitat, the water can't go over them during high flows, so will simply squeeze round the sides of the obstruction, undermining the banks causing the banks to collapse therefore losing vital habitat.

different types. During the month of April the DDSFB staff has been busy clearing all 32 obstructions from the Leochel catchment. Some of these blockages are man made weirs; others consisted of discarded tractor tyres, fencing, farm gates, wooden pallets, and livestock feeding buckets. All together over the Leochel catchment we removed 9 discarded tractor tyres.

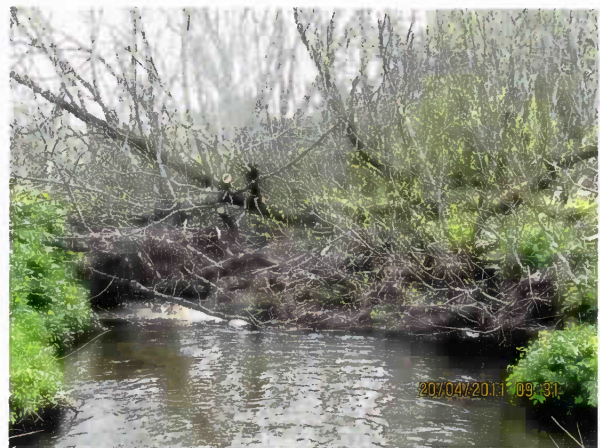
Pic 1

Before clearing

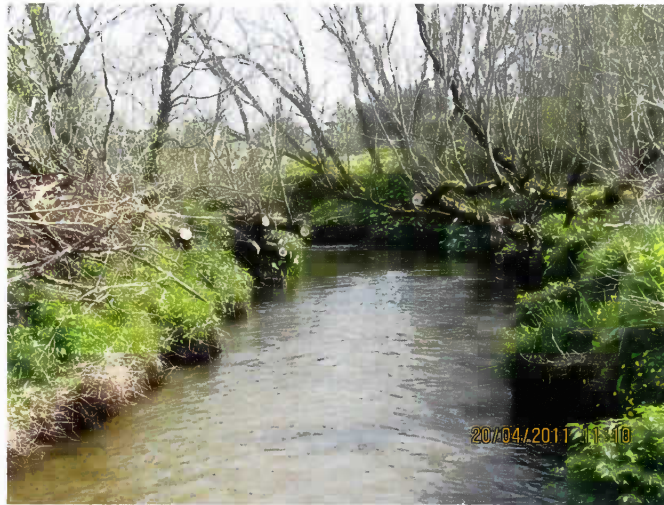
Pic 2

After clearing

As you can see by the picture above how the channel looks now, the willows have been cleared and the stream is now flowing freely once more.

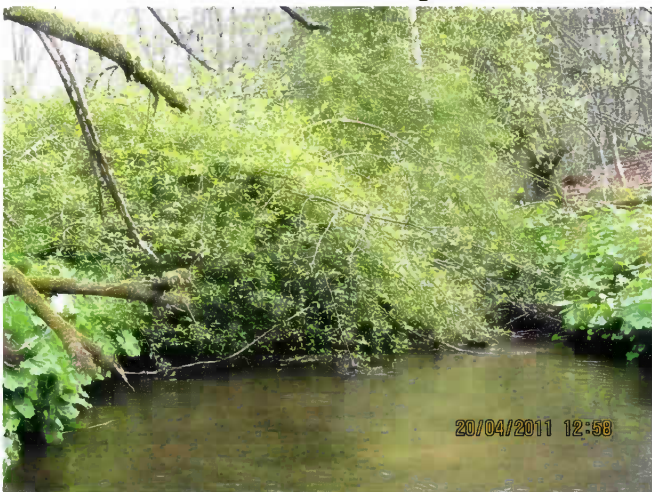
Pic 1 before clearing

These two pictures in this section of the Corse burn of before and after is a good example of other serious damage caused by blockages, in Pic 2 you can clearly see how fine sediments of sand have smothered out all aquatic vegetation, spawning gravel and I suspect there would be very little aquatic insects for fish stocks to feed on. Now the DDSFB staff has successfully cleared the 32 blockages over the Leochel catchment area, this should add to more spawning habitat and improved bank habitat. The areas that have also been coppiced will let in more natural light to the stream banks which will create improved bank vegetation and insect life. We have now moved on to the Goval Burn at Dyce.
